REPORT NO. CASD/LVP 78-078  
CONTRACT NAS 3-20644

## ATLAS 5013 TANK CORROSION TEST

# ATLAS 5013 TANK CORROSION TEST

December 1978

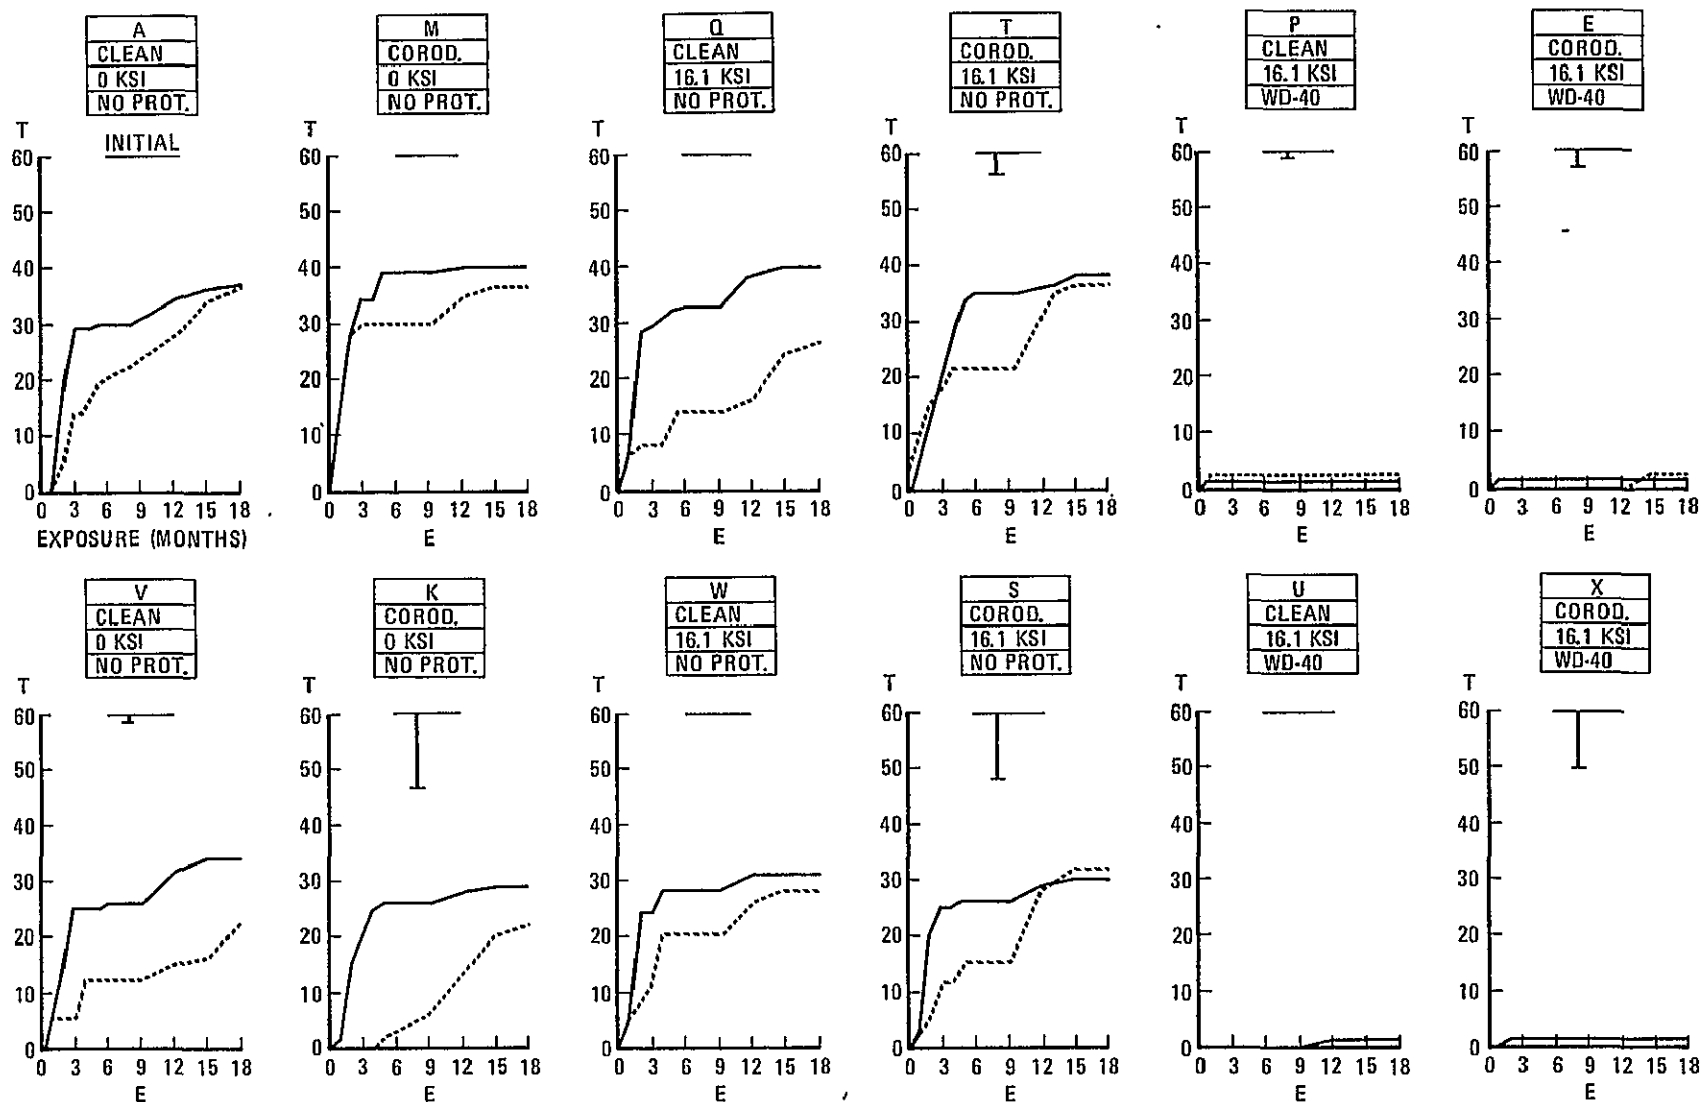
Figure 5-4. Test Results for the Splice Joint of Each Specimen

The results of the splice joint (Figure 5-4) followed a somewhat similar pattern. It should be recalled that the splice joints were made just prior to exposure at Pt. Loma. They were made under optimum factory conditions and were initially clean and uncontaminated. The first indications of corrosion were not noted until after four or five months. Two unprotected specimens were unaffected even longer.

The four WD-40 protected specimens had no indications for their entire exposure period. It should be noted that the change of the WD-40 application period from 30 to 90 days on specimens E and X for the final nine months had no effect on the number of corrosion indications.

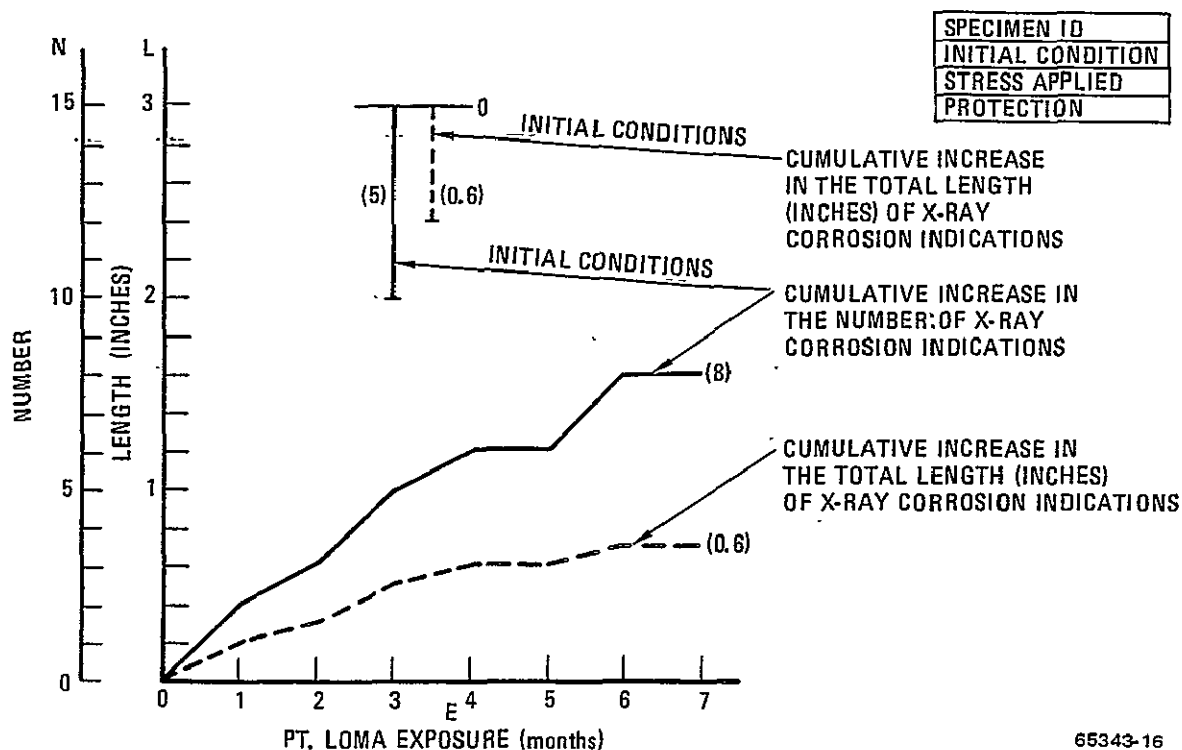
Figure 5-5. Test Results for Each Specimen as a Function of Exposure Time

Figure 5-5 shows the total corrosion activity (corrosion pits and corrosion indications) during the exposure period. It can be seen that corrosion pits were observed in most cases during the first month. As exposure time increases, the total number of corrosion pits and indications becomes relatively constant. It was noted that the corrosion pits turn into indications. This levels off the totals. It is also apparent that the totals for the splice joint somewhat lag the tank joints. This is especially true during the initial and middle stages of exposure. The WD-40 specimens were essentially unaffected by the exposure. It is interesting to note that specimen E shows one or two pits after the WD-40 protection interval was changed. However, specimen U also showed a pit during this interval. Its protection was not changed. It seems that no real changes took place because of the modification of the WD-40 application.

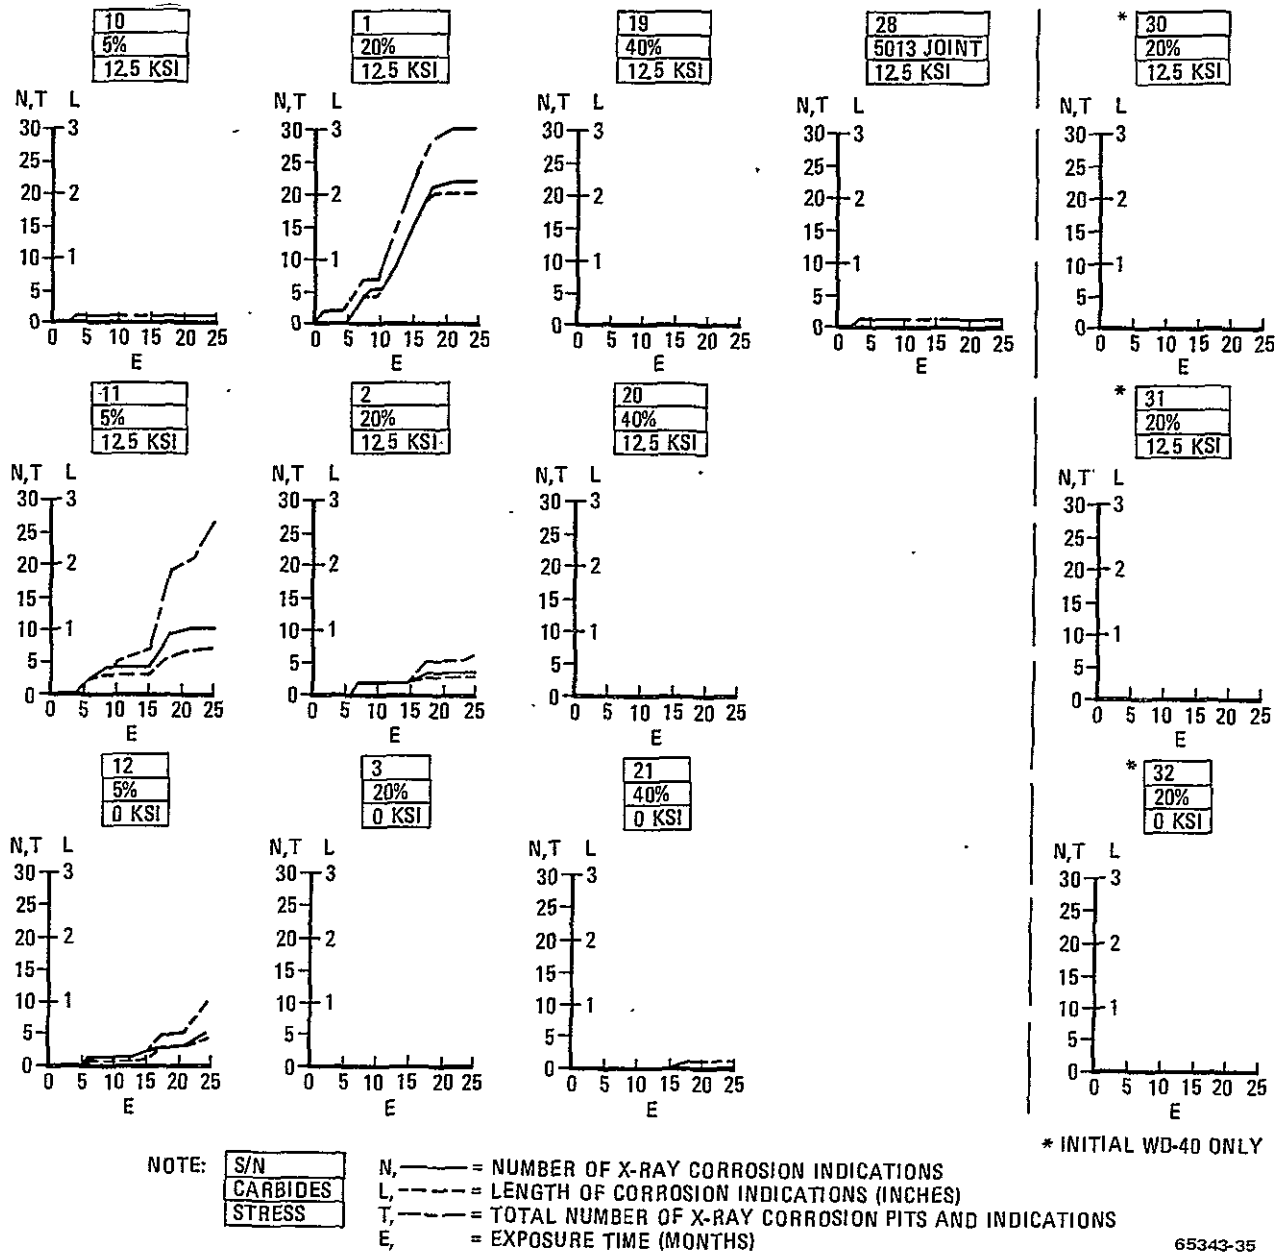
Figure 6-4. ETR Environmental Exposure Effect on Test Specimens Having No or Only Initial WD-40 Protection

Figure 6-4 shows the effect of the exposure on specimens that were unprotected by WD-40. With the exception of specimens 30, 31, and 32, which had WD-40 applied only when they were initially exposed, the specimens had no protection during their entire exposure.

An analysis of Figure 6-4 shows that much less corrosion occurred than noted on the Pt. Loma specimens. However, the environment probably was less aggressive. The

ETR specimens were farther from the ocean and were somewhat protected by the service tower. This more benign environment probably also contributed to the inconsistency of results. Only about one-half of the unprotected specimens, which would have been expected to corrode, did so. The results also show that the tensile stress and percent of undissolved grain boundary carbides had little influence, if any. Studies in this program have revealed that the grain boundary carbide effect does not influence the surface. Therefore, for these exposures, it now seems logical for the percent carbides to have no influence on the results. (See Section 2, Metallurgical Analysis.) Specimen 28, which was prepared from a 5013 joint section, was also essentially unaffected by the exposure. However, it should be noted that some evidence of WD-40 was observed on this specimen during post-exposure examination. Its history, with respect to WD-40 protection, therefore, is questionable. According to the procedures it should have not seen any WD-40. Examination of the other specimens revealed no inconsistencies.

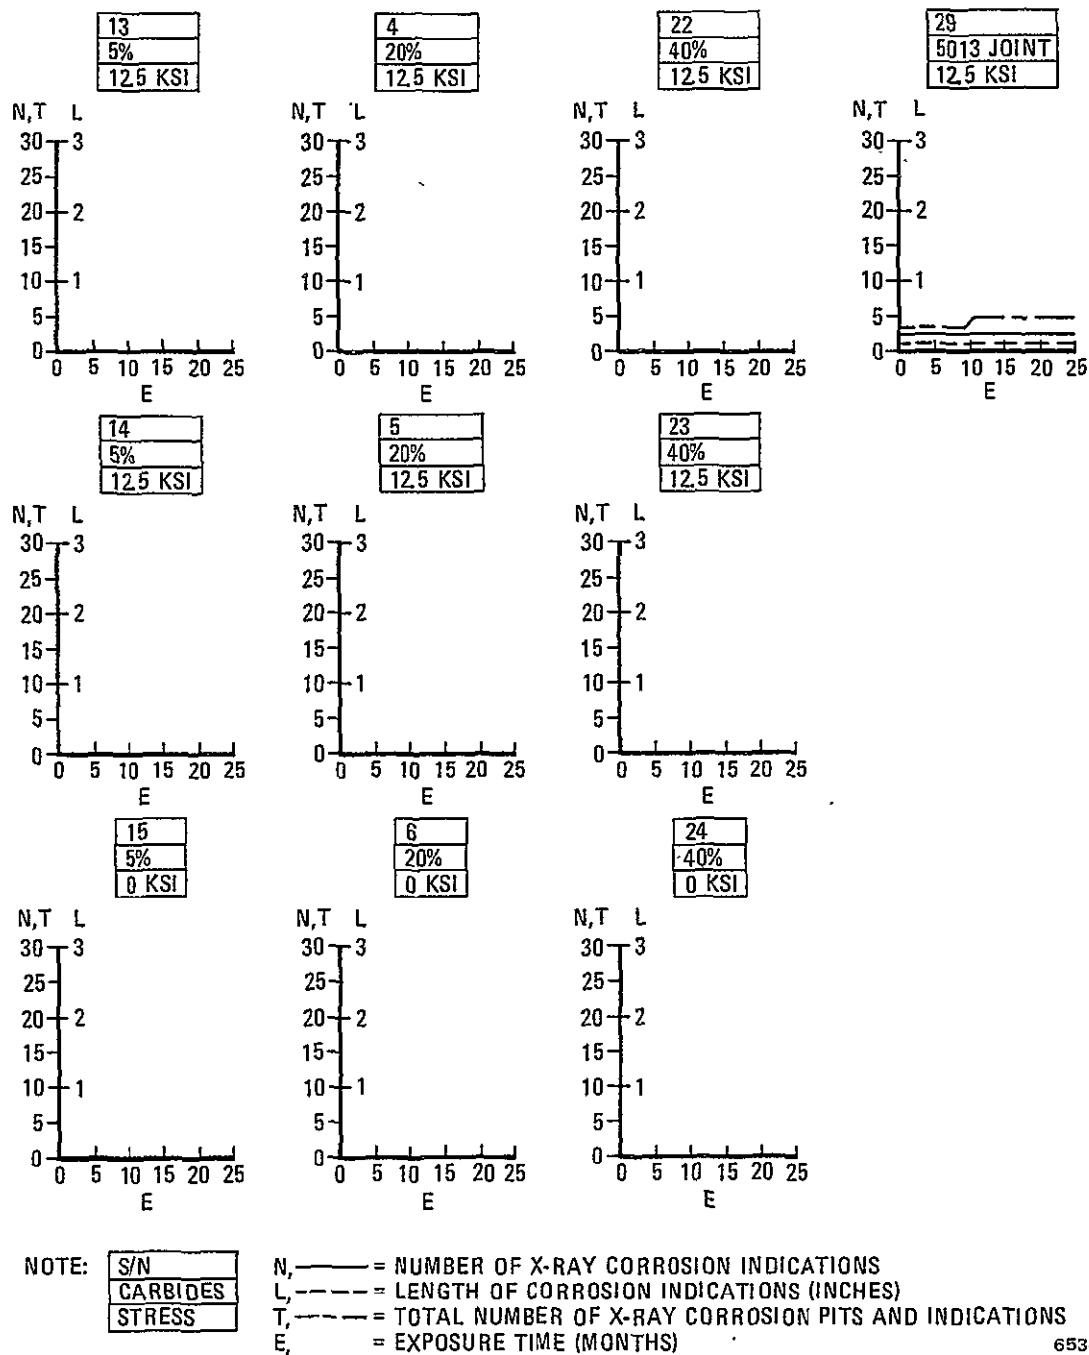
Figure 6-5. ETR Environmental Exposure Effect on Test Specimens Having WD-40 Protection Every 30 Days

Figure 6-5 gives the results of the specimens that received WD-40 protection every 30 days.

Figures 6-5 and 6-6 document the results of 19 dogbone specimens that were protected either every 30 or 90 days with WD-40. Specimen 29, which was made from 5013 joints, had initial corrosion. WD-40 was effective in stopping any further significant increase in corrosion. All of the other protected specimens showed no signs of corrosion whatsoever. It is what one would expect, however, based on the Pt. Loma specimen results (Section 5). It should also be kept in mind that these WD-40 applications were made in a very controlled manner according to explicit engineering instructions. It should also be noted that the service tower environment the specimens were exposed to may be somewhat different from that experienced by a tank section. Cryogenic tanking, residue being washed onto the surface, or other unknown factors were not completely duplicated for the test specimens. Their material makeup and general exposure location were the main similarities to the 5013 tank.

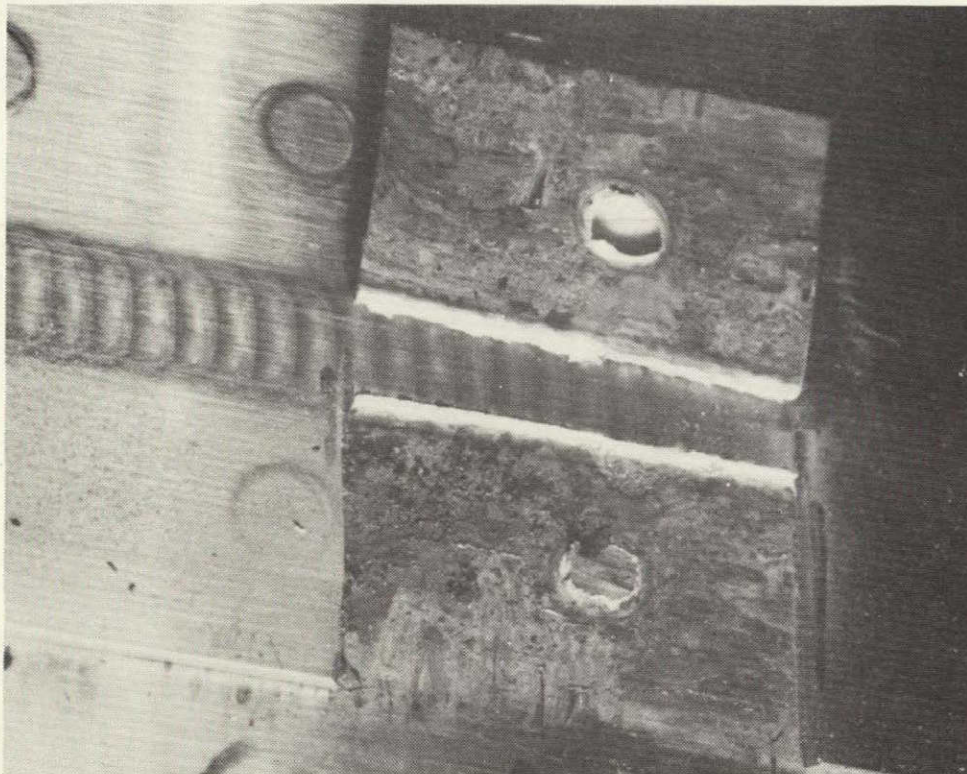
Figure 7-1. Sample B Cut from 5013 Tank

The identification, condition of the surface of specimens, and results of the WD-40 analysis are shown in Table 7-1. Sample B represents one of the most corroded areas and is shown in Figure 7-1. Sample F, shown in Figure 7-2, is typical of a noncorroded area. Further details are found in Reference 2.

A review of the data in Table 7-1 shows good correlation between rusty samples and low WD-40 and clean samples and high WD-40. Samples 3 and 5 are notable exceptions. Sample 3 was clean and had low WD-40. This could be explained by the possibility that no corrosive reached this area. Sample 5, on the other hand, measured high on WD-40 and had slight corrosion. Some rust may have been transported from an adjacent area because water marks are definite on the specimen.

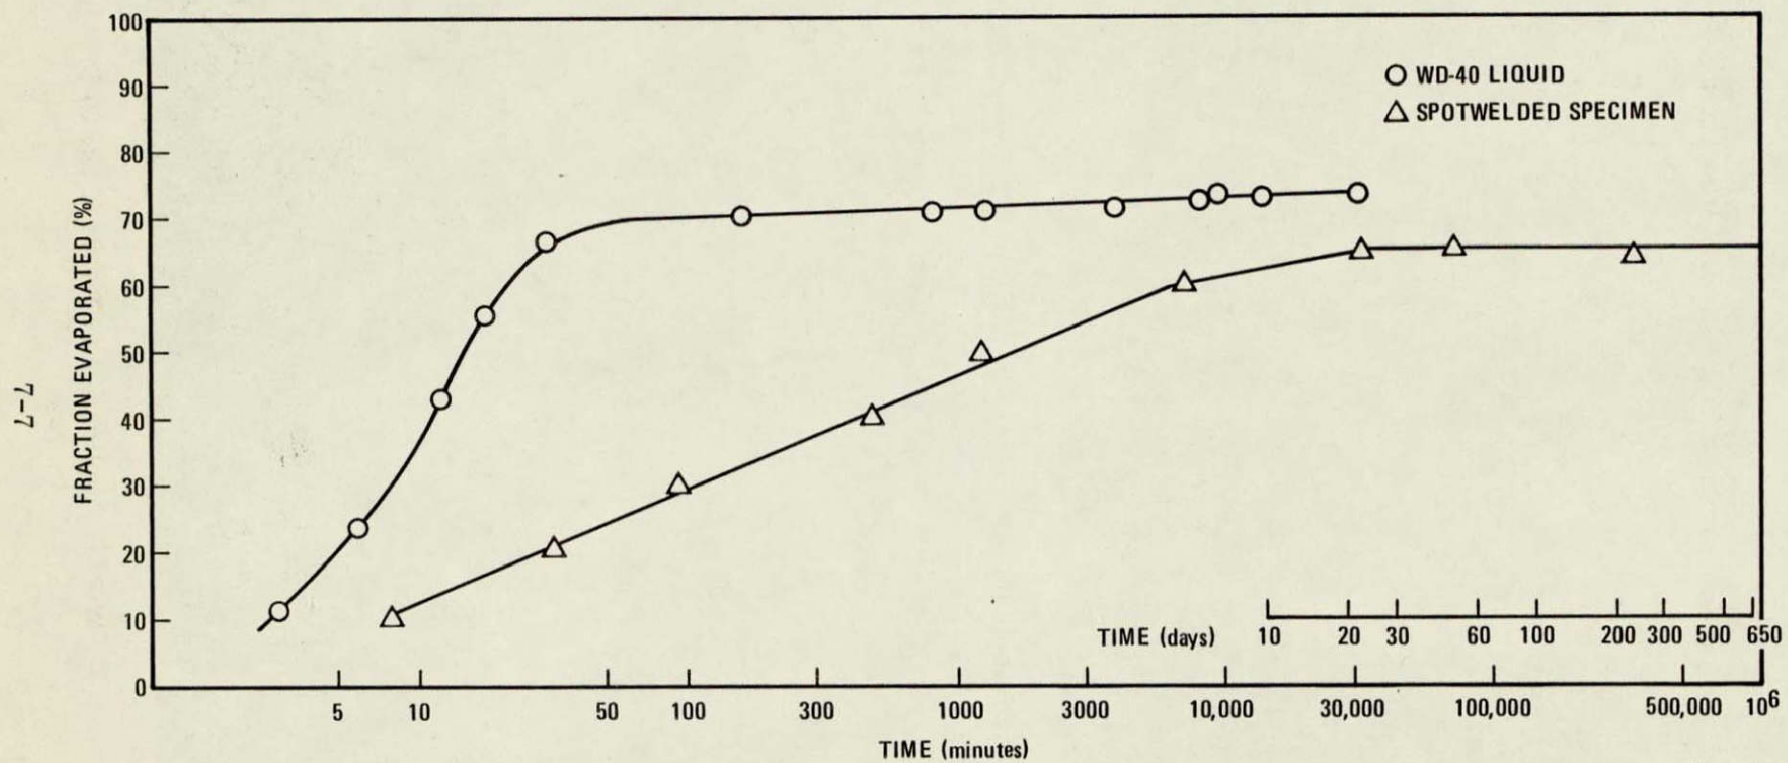
Figure 7-6. WD-40 Weight Loss as a Function of Time

On the other hand, where the fluid is restricted from the air as in the joint, Figure 7-6 shows that the initial evaporation is much slower. It finally reaches equilibrium at about 30 days with 35% retained. After that, the loss is very low even out to one year. It is probable that with time the oil thickens due to air oxidation and by dust accumulation.

These direct tests, independent of variation in gap thickness or application technique, clearly show that WD-40 does not lose its effectiveness because of evaporation. Accumulation of soil or other factors may reduce its effectiveness. These factors are investigated by corrosion tests reported in Sections 5 and 6.

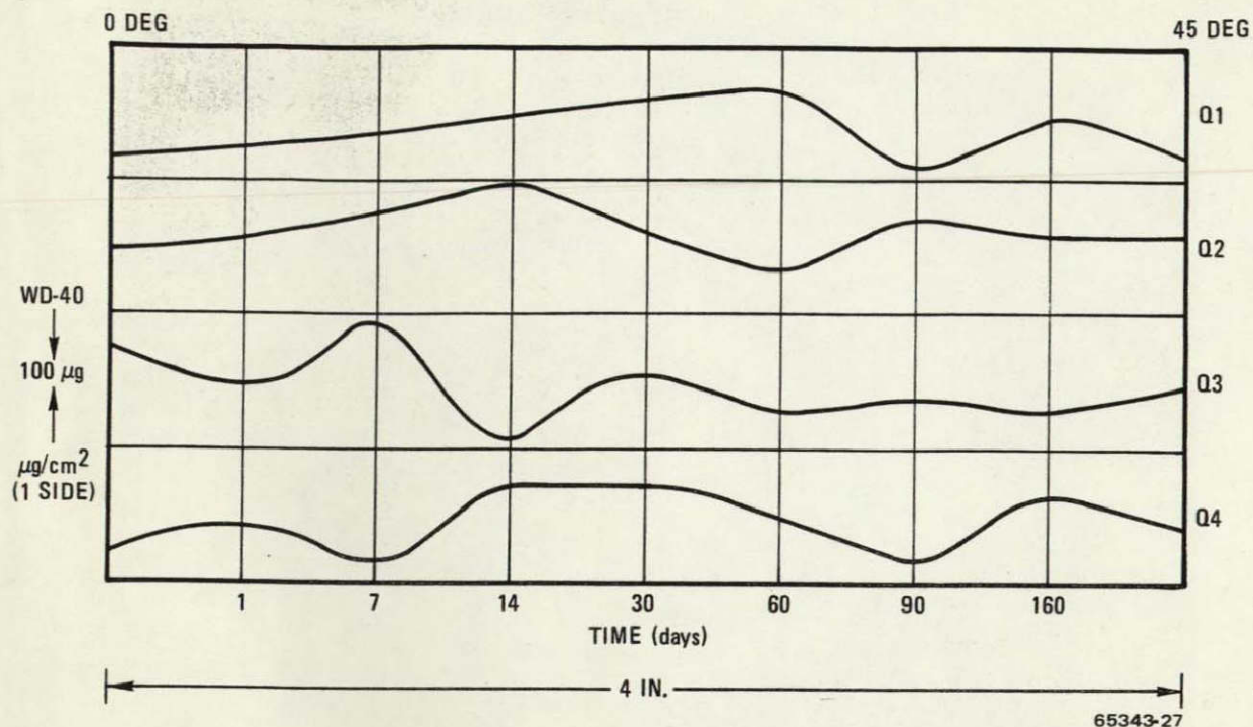
Figure 7-10. Persistence of WD-40 as a Function of Time and Sample Location (No Water)

Sampling was done initially and at 1, 7, 14, 30, 60, 90, and 160 days. The residual WD-40 as a function of time, sample location, and water spray is shown in Figures 7-10 and 7-11. A study of this data shows random values for both the water-sprayed areas and nonsprayed areas. The expected gradual decrease in residual WD-40 is not apparent.

At this point, a test was performed to determine the precision of the residual WD-40 test. A thin sheet of stainless steel was uniformly coated with WD-40 to a thickness similar to the average seam results. The precision data in Figure 7-12 clearly shows that the variations in Figures 7-10 and 7-11 cannot be explained by variations in the WD-40 determination.

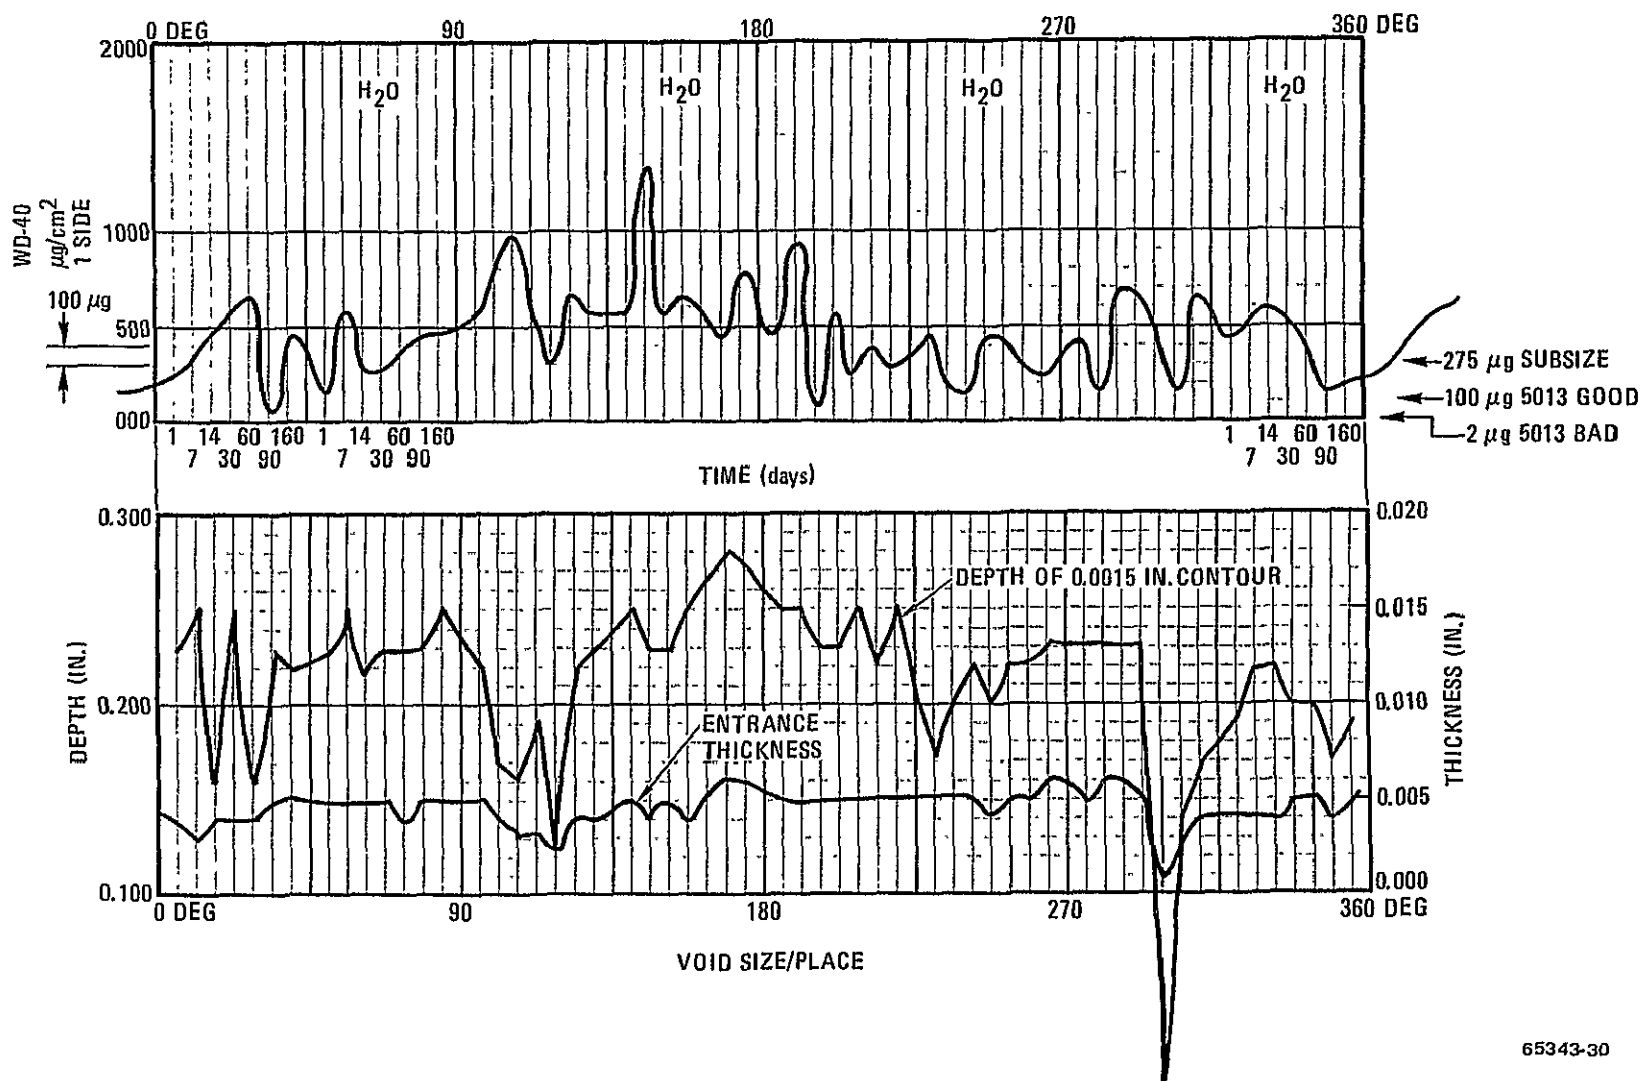
Figure 7-13. Comparison of Void Size and Residual WD-40 as a Function of Seam Length and Time

In a further effort to explain the data, measurements were made of the thickness and depth of the void volume of the seam as a function of the length of the seam. The void size data is plotted in Figure 7-13 in such a way that it can be compared with the residual WD-40 data as a function of position along the seam. From these comparisons the following conclusions can be drawn.
